Examination & Recommend Action

BRIDGESTONE
AIRCRAFT TIRES

TIRE SPECIFICATION &
MAINTENANCE MANUAL

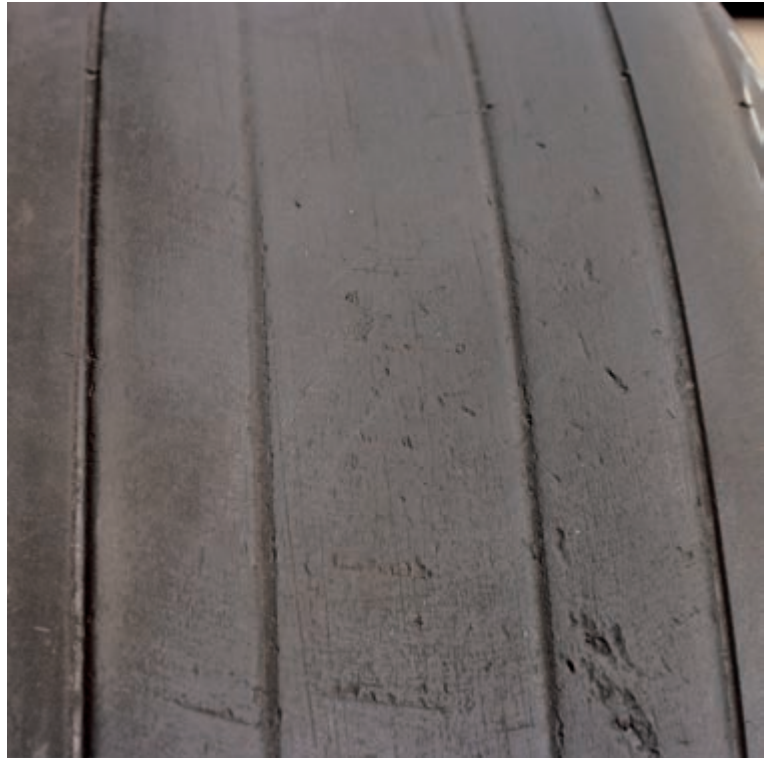
NORMAL TREAD WEAR

Rubber is worn out evenly across the tire tread.

Even tread wear indicates that tire pressure has been maintained at the correct inflation level during service.

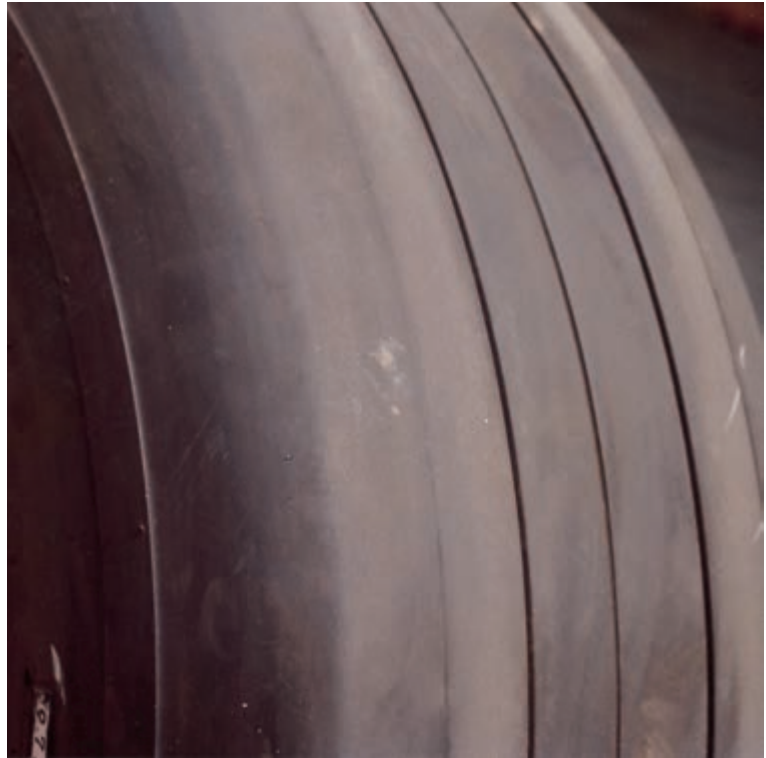
UNEVEN TREAD WEAR (SHOULDER)

Rubber wearing is much progressed at “shoulder area” of tread.

Underinflation will lead to excessive tread shoulder wear. It will also lead to high tire deflection and subsequent heat build-up which may result in tire damage.

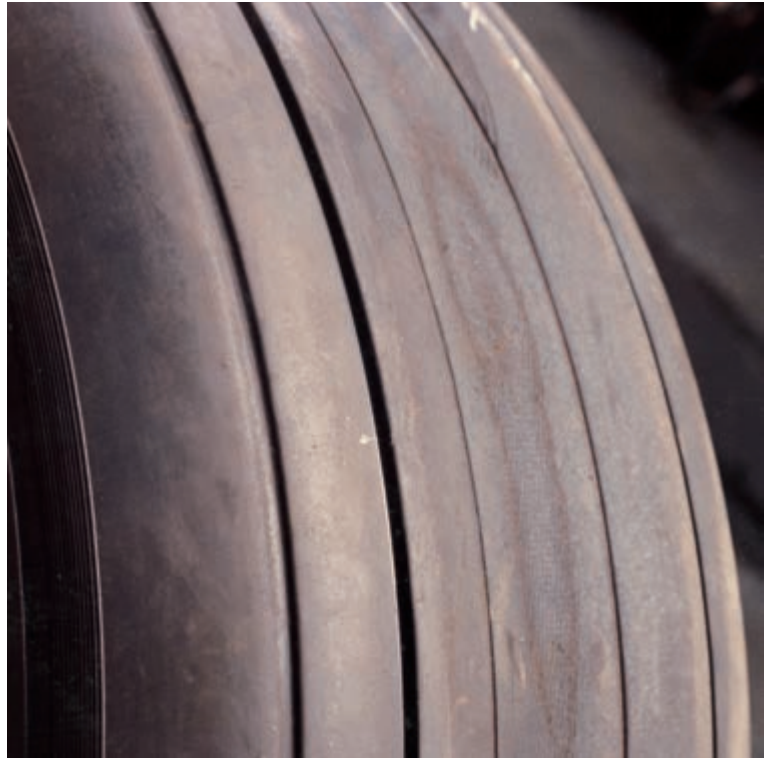
UNEVEN TREAD WEAR (CENTER)

Rubber wearing is much progressed at “center area” of tread.

Overinflation accelerates center tread wear, reduces tire traction and makes the tread more susceptible to cutting by foreign objects.

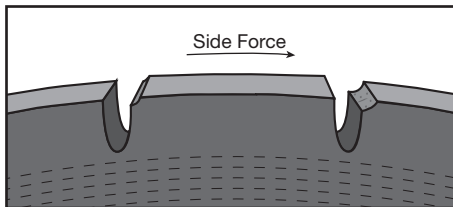
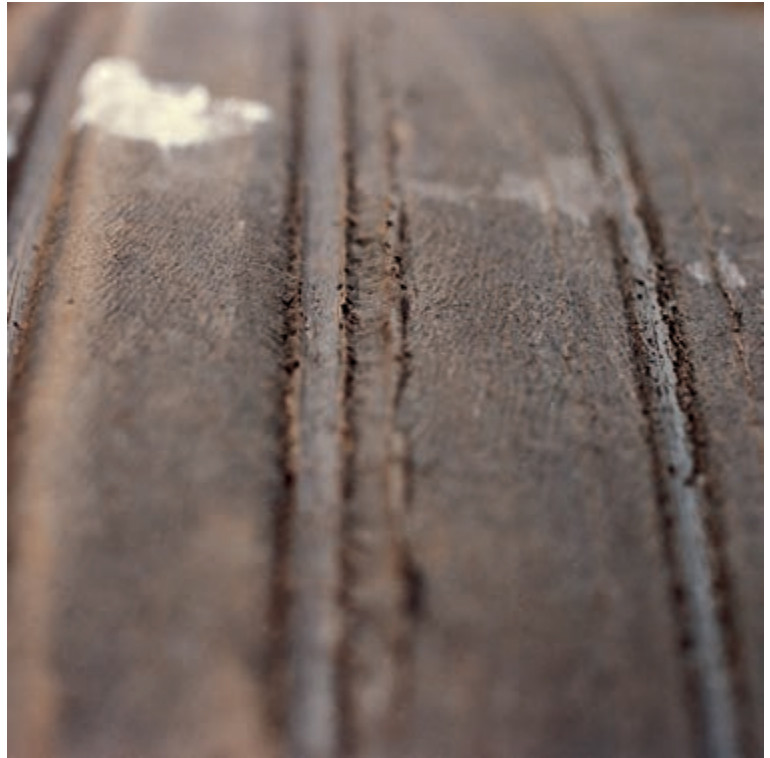
IRREGULAR WEAR: ABRASION

Tread surface becomes quite rough, or slightly melted.

Refers to abrasive wearing of the tread caused by sudden, strong side forces.

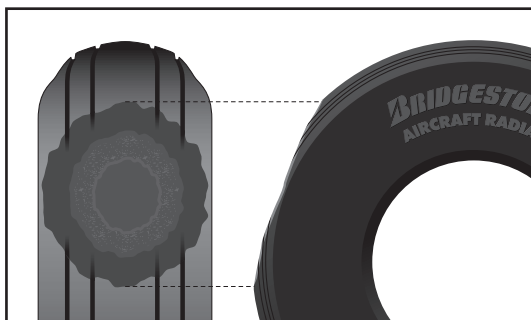
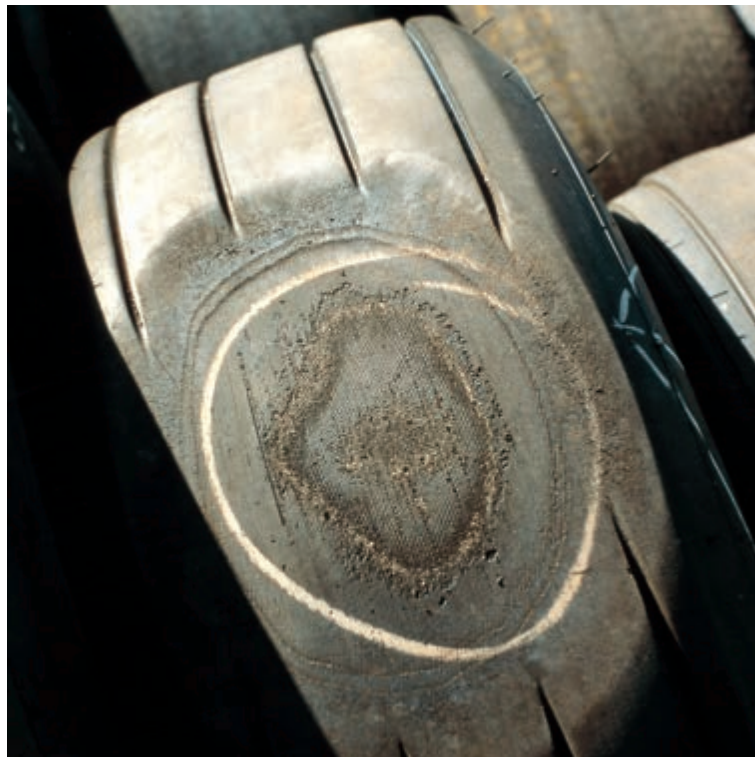
SPOT WEAR

Quite deep rubber wearing happens at singular location of tire.

Skid burns result from brake malfunctions or locking of the wheel, most often during landing.

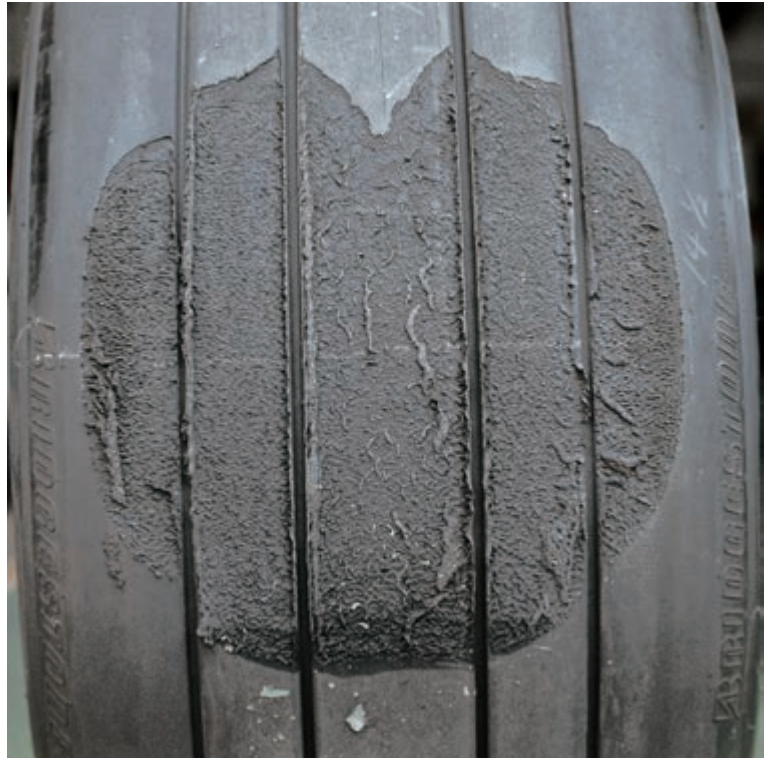
TREAD RUBBER REVERSION

A patch of tread rubber is melted or scorched.

An oval shaped burn on the tread most often is caused by hydroplaning on wet or frozen runways during landing.

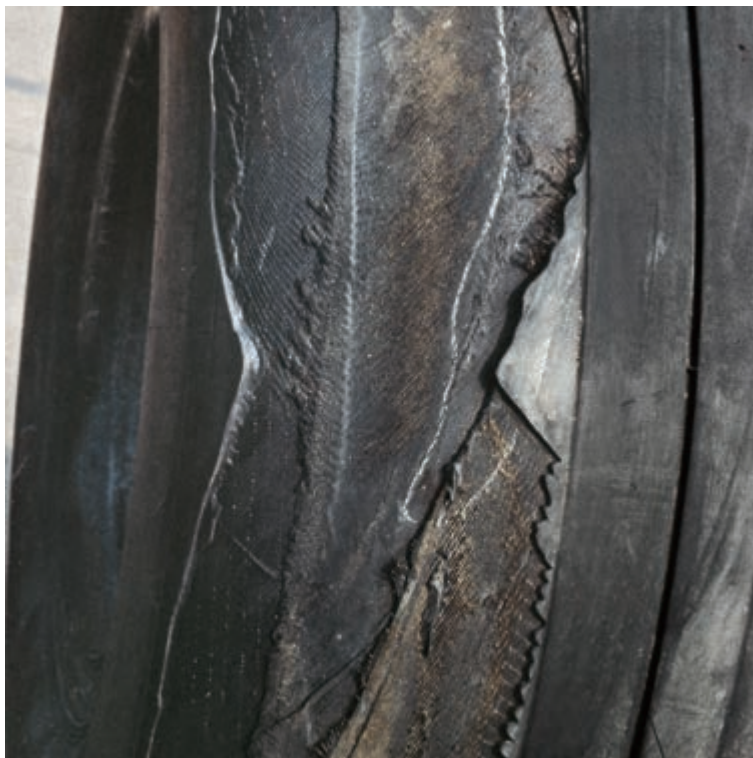
TREAD SEPARATION

Internal separation happens between tire components at tread area. Part of tread rubber and / or fabrics are lost and internal construction is exposed.

Separation of the tread or fabric is caused by overloading, cuts, abnormal heat built-up, etc.

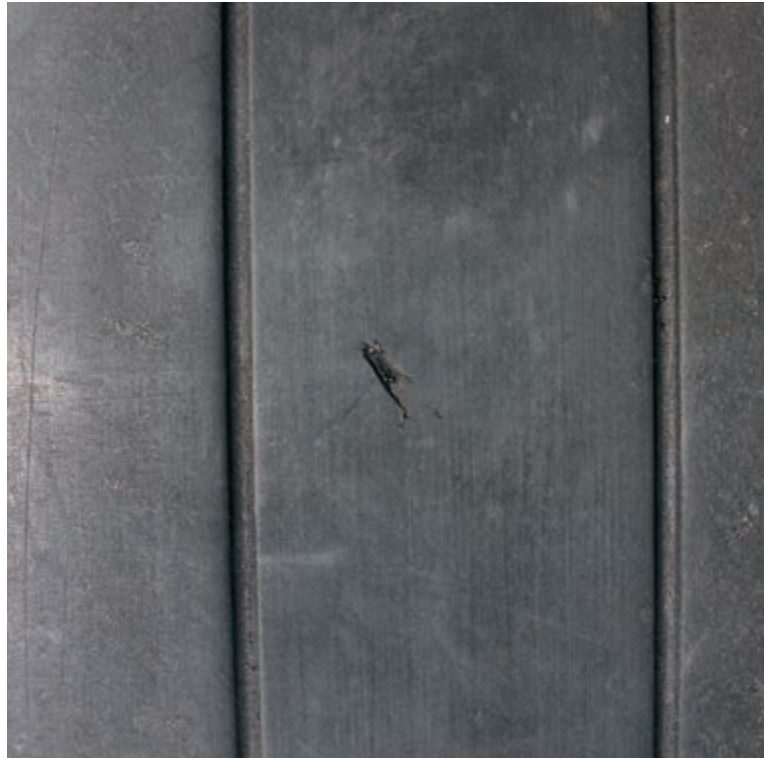
CUTS

Cuts are most often caused by foreign objects present on runways or taxiways.

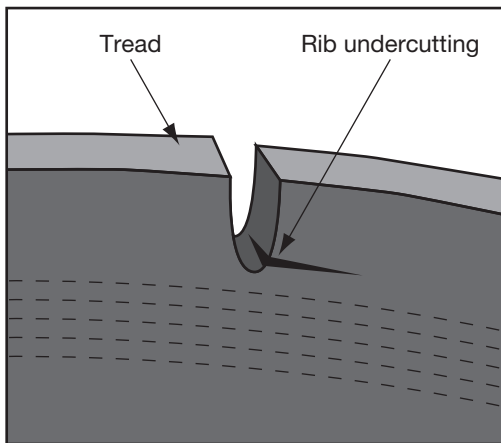
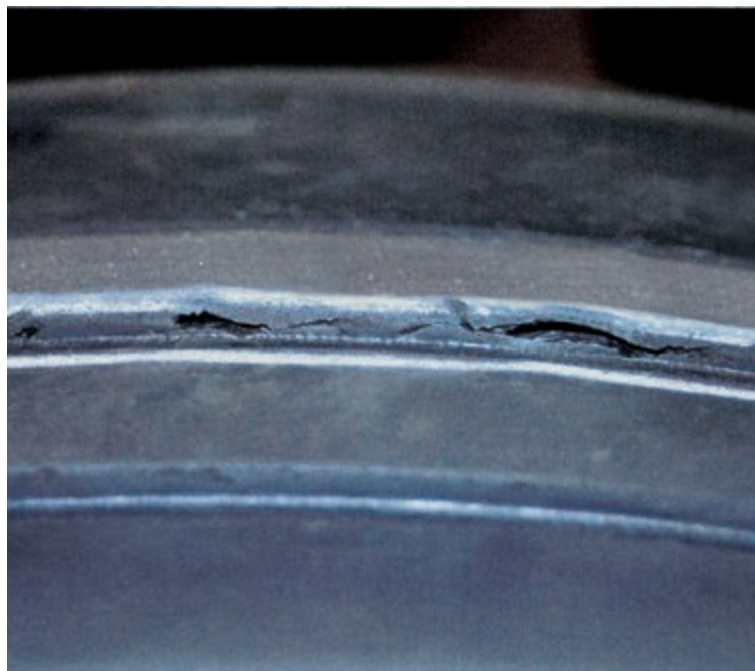
RIB UNDERCUTTING

Rubber cracks happen at the “wall” of the “tread-rib” in tread grooves. The cracks spread underneath the ribs.

An extension of groove cracking progressing under a tread rib which can lead to tread chunking, peeled rib or thrown tread.

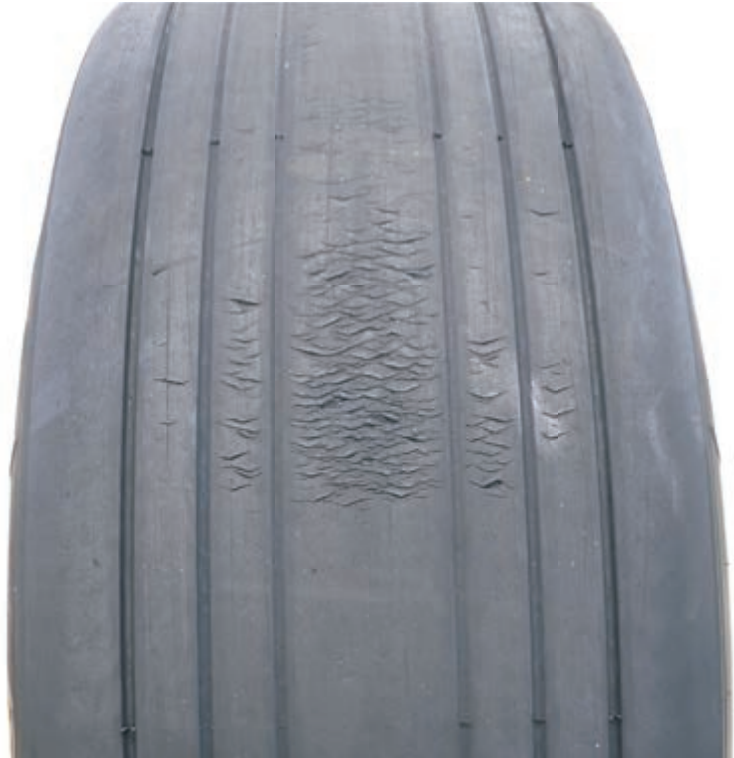
CHEVRON CUTTING

Superficial rubber cuts happen on the tread. The cuts are shaped as “v” and extend across the tread.

This phenomenon usually occurs on grooved runways at aircraft touches down, the tires are rotated rapidly and damaged by the runway groove edges.

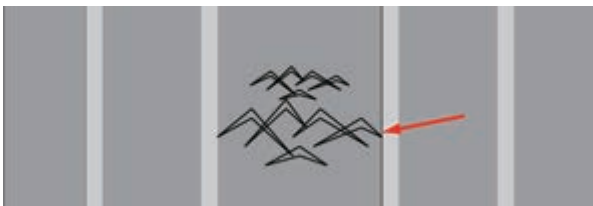
If the chevron cuts extend across a rib from groove to groove, or locate in tightly linked distance each other, remove such tire from the aircraft. If this kind of chevron cut occurs at the end of wear level, there is concern of tire tread tearing.

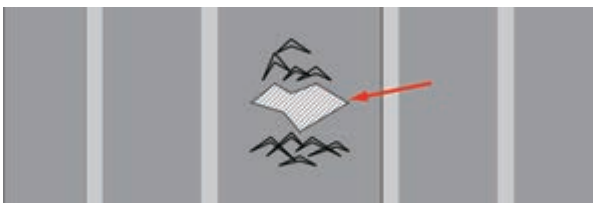
If the cut protector is exposed over 5 cm² due to tread chunking, remove such tire from the aircraft.

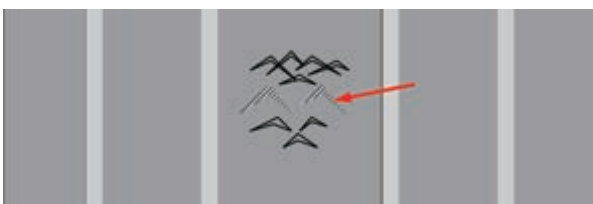
If more than one chevron cut reaches to the cut protector, remove such tire from the aircraft.

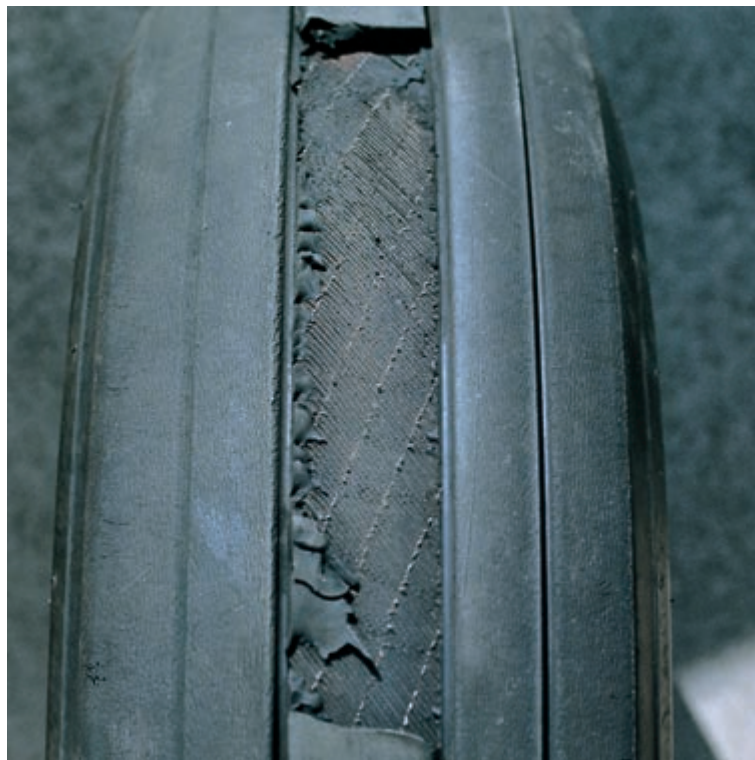
PEELED RIB

This condition occurs when a tread rib partially or totally peels off in a circumferential direction. Usually beginning with a cut in the tread, it results in a circumferential delamination of a tread rib away from the tire carcass.

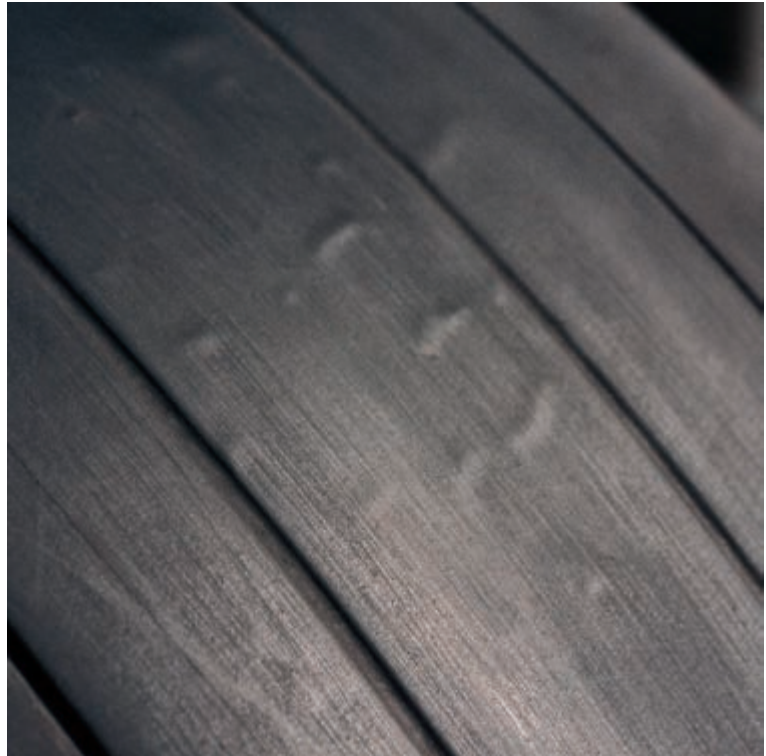
BULGE ON THE CROWN SURFACE (DEFLATED TIRE)

Severe operating conditions may cause local reinforcing fabric nylon cord to rupture. When such tires are deflated, small bulges (i.e. surface swelling) may appear on the tread surface. This phenomenon is due to the stretching of rubber around the ruptures in the reinforcing fabric and does not pose any problems once the tire is retreaded as the reinforcing fabric is replaced.

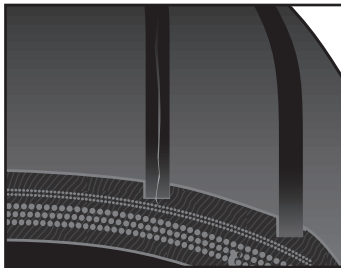
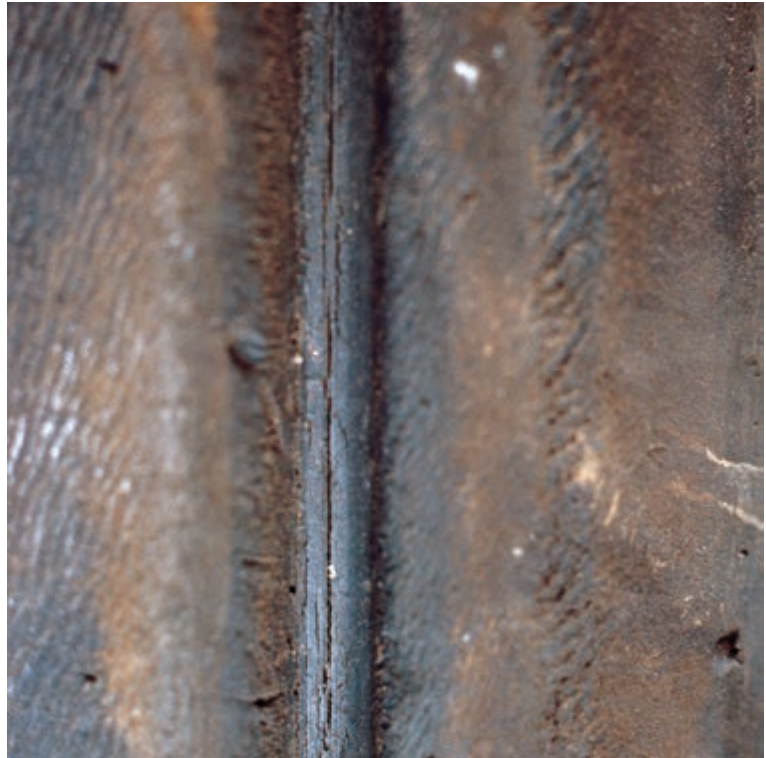
GROOVE CRACKING

Groove cracking may result from environmental aggression of the rubber (ozone attack for example) or from an excessive mechanical solicitation, insufficient inflation of the tire. These cracks occur at the bottom of the tread groove pattern.

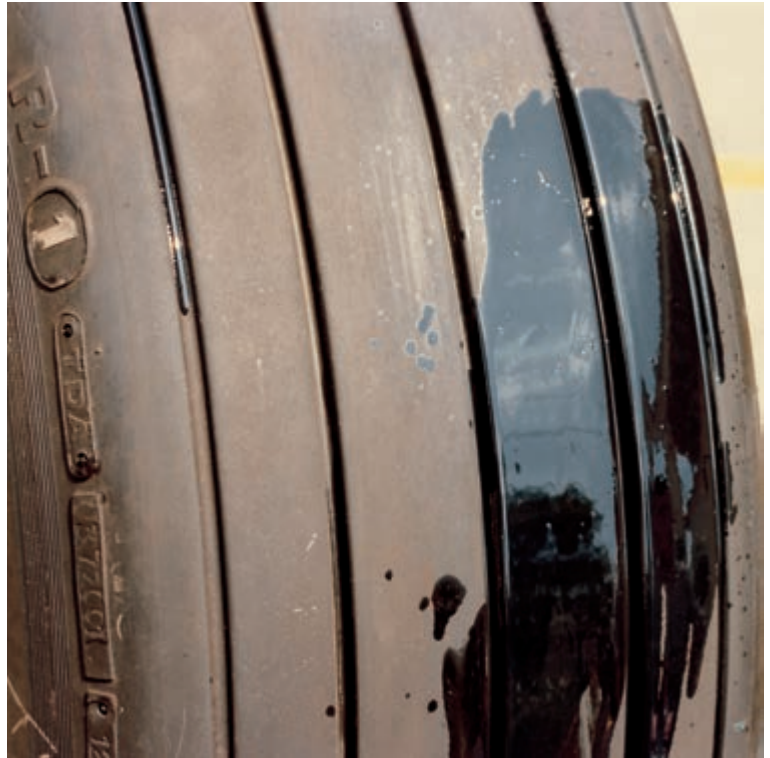
CONTAMINATION

Hydraulic fluid, fuel, tar oil, solvent, chemicals and hydrocarbons deteriorate tire rubber.

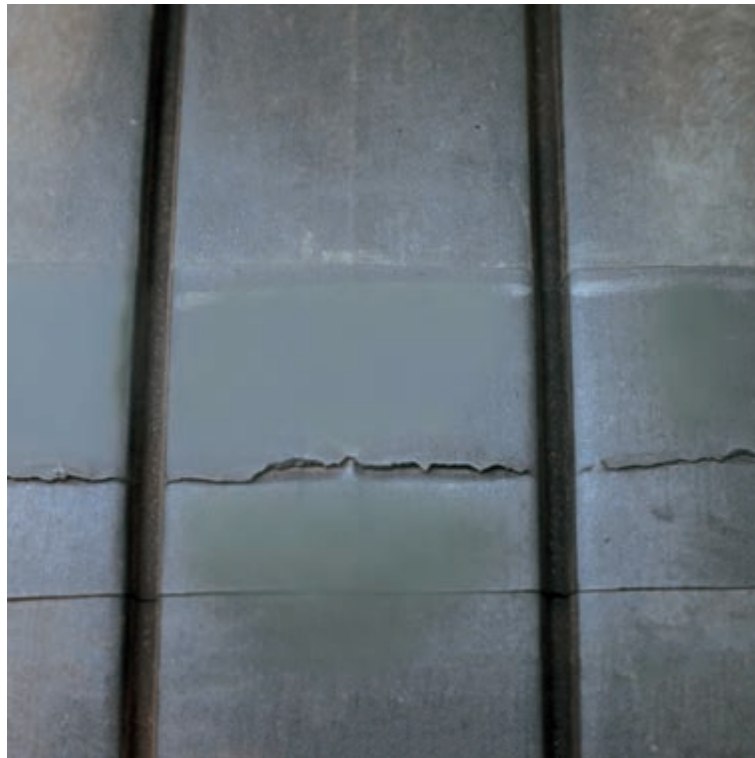
OPEN TREAD-SPLICE

Denotes a tire defect where the tread joint or splice separates in a radial direction during operation.

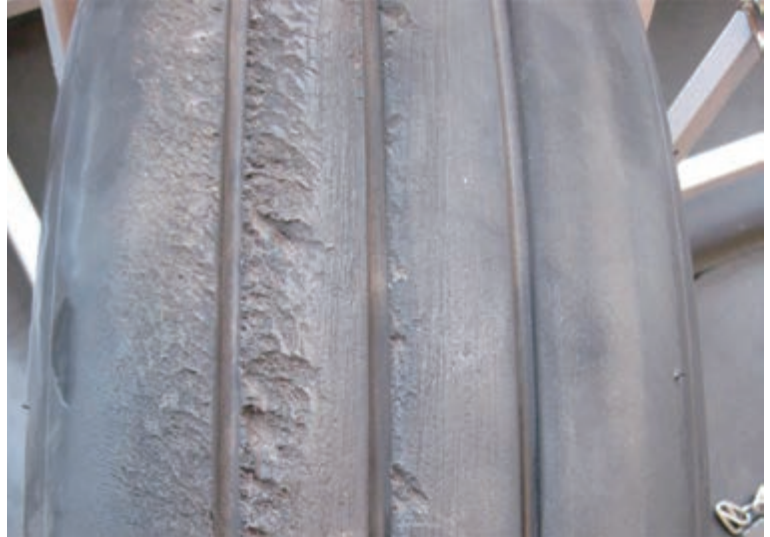
CHIPPING AND CHUNKING

Relatively smaller “gouges” occur on tread surface. Small amount of tread rubber is missing.

Quite strong Lateral-Force is applied on the tread surface during operation. Typical maneuver result in this phenomenon is: cross-wind landing, high speed cornering, and tight-turning.

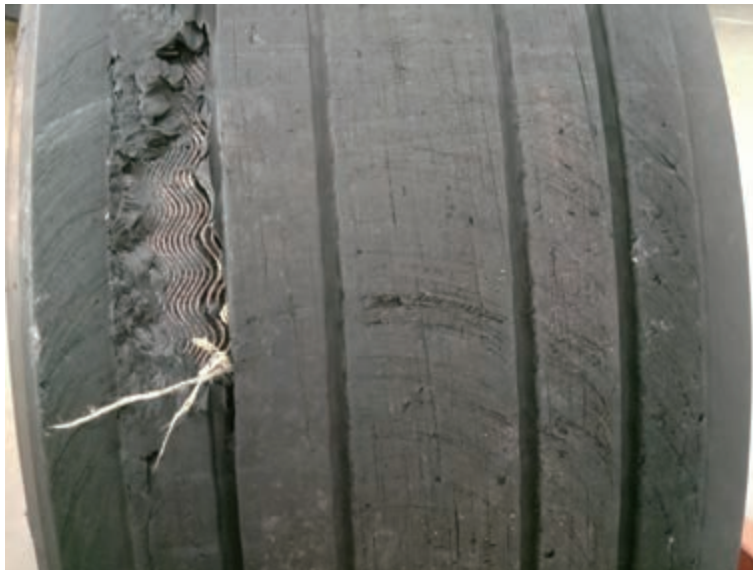
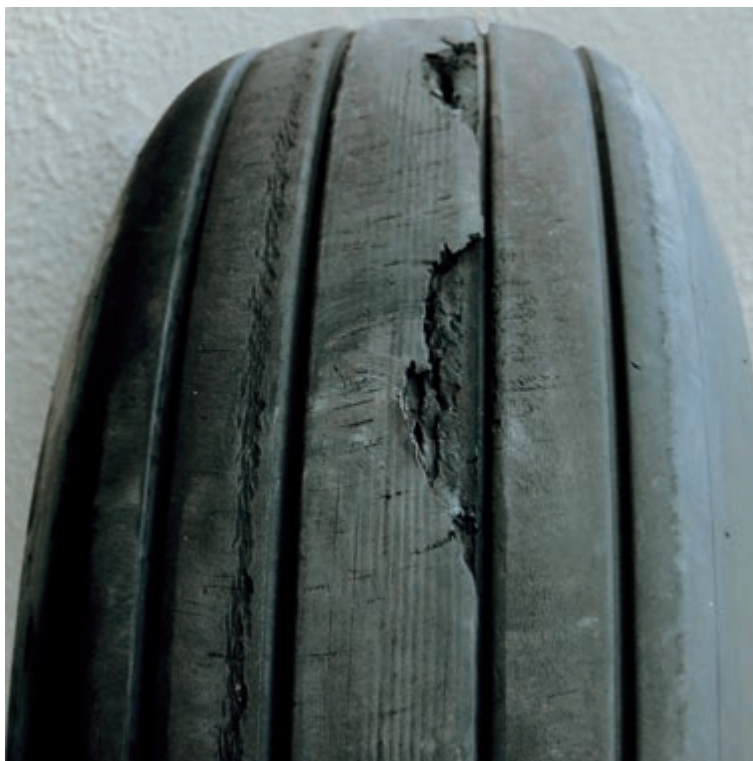
RIB TEARING

Rib tearing occurs when a tire is subjected to an extraordinary side force during cross-wind landing, high speed cornering, and sharp-turning.

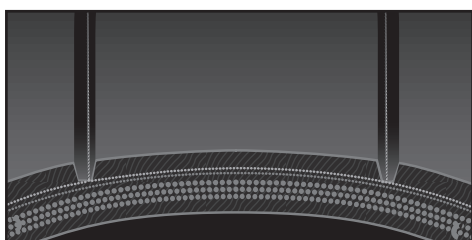
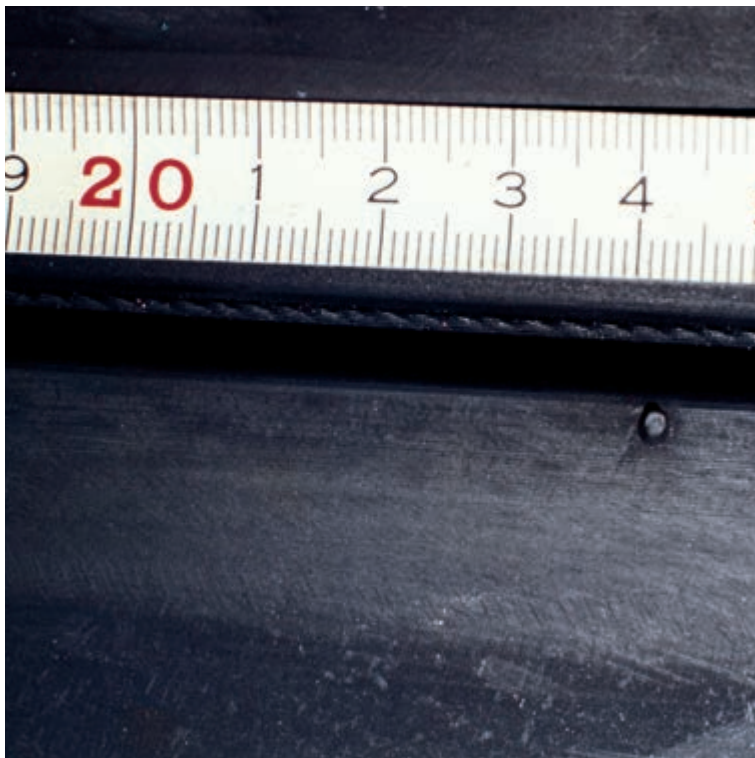
CORD EXPOSURE IN TREAD GROOVE

When rubber gauge in the tread groove is thin, the reinforcing fabric pattern may become visible at the base of the groove. Tires with this condition are airworthy.

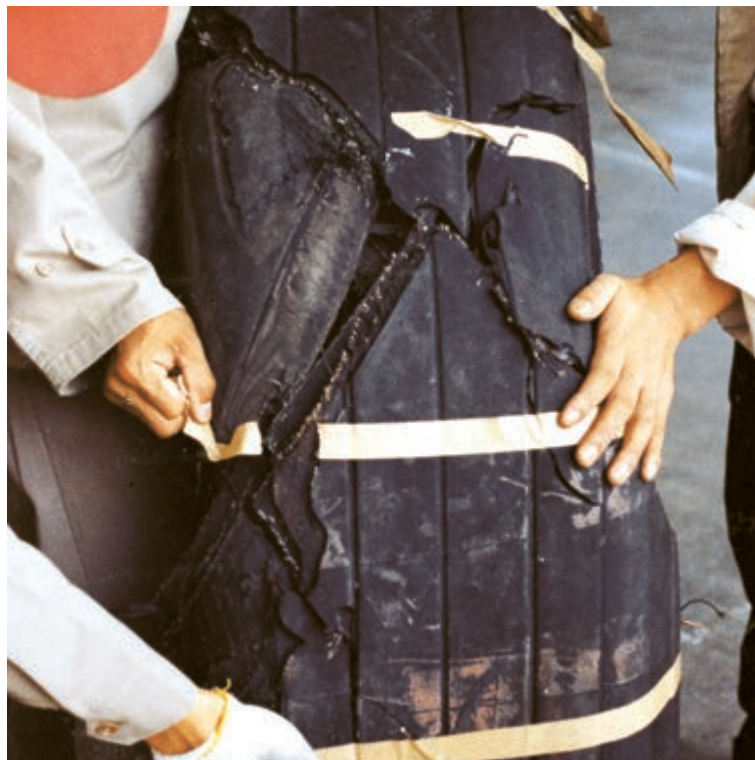
IMPACT BREAK

For bias tires, FOD and shock bursts are typically identified by diamond or X-shaped ruptures of the tread and carcass sustained by rolling over foreign objects. The photograph shows a damaged tire restored to its original shape and the cause of the failure being investigated.

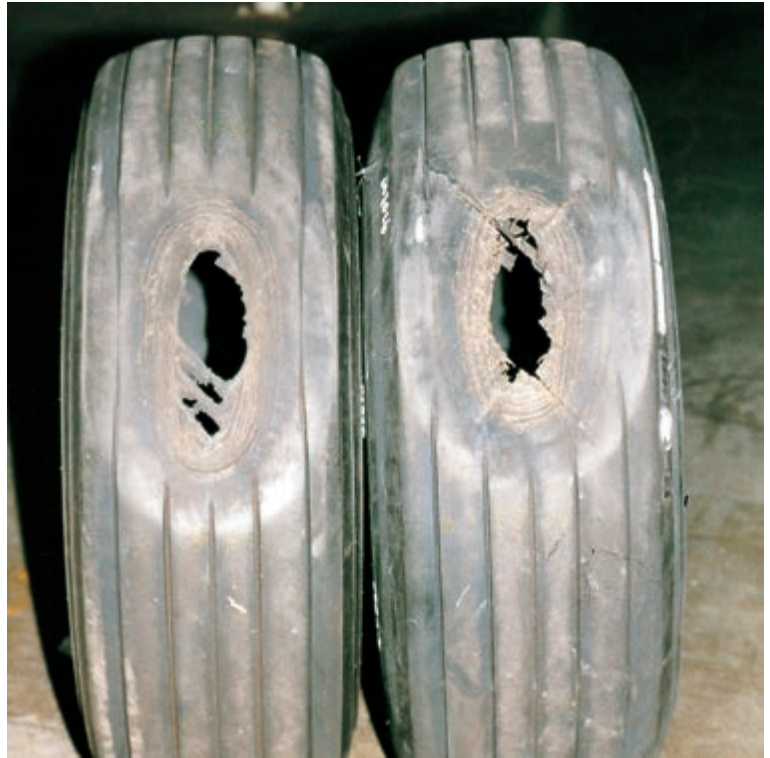
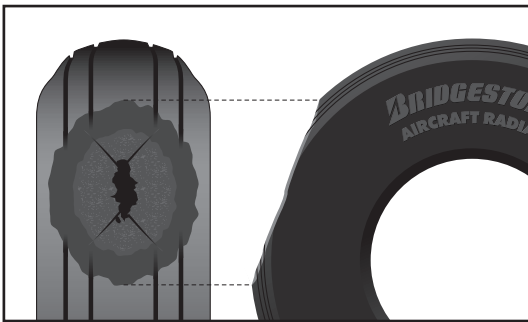
SKID BURST

Skid bursts result from brake malfunctions or locking of the wheel, most often during landing. Without tire rotation, the rubber and carcass plies are quickly worn through leading to the bursting of the tire.

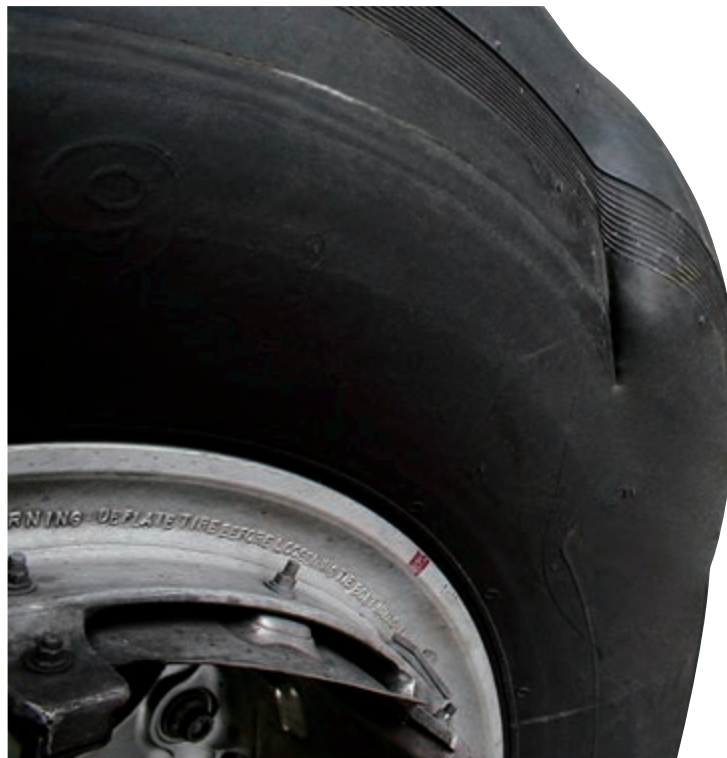
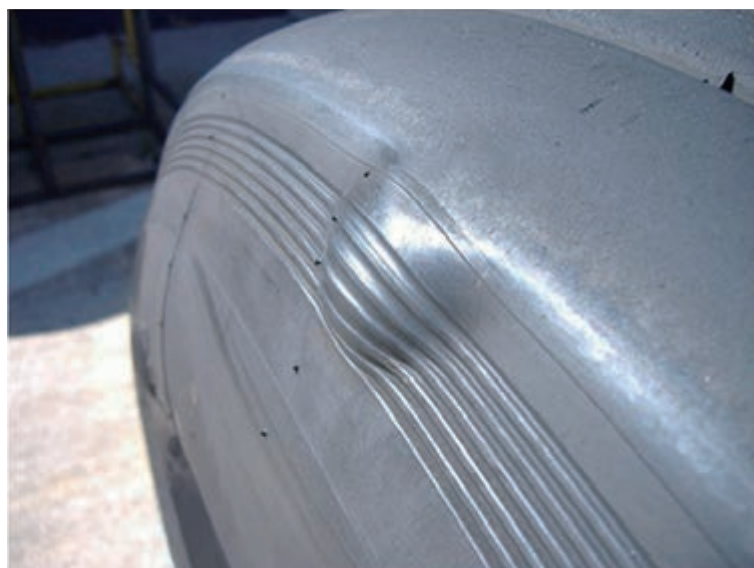
BULGE/BLISTER

Bulges and blisters indicate a separation or damaged tire.

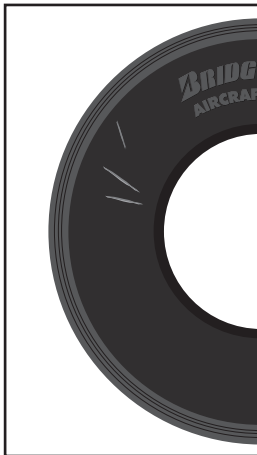
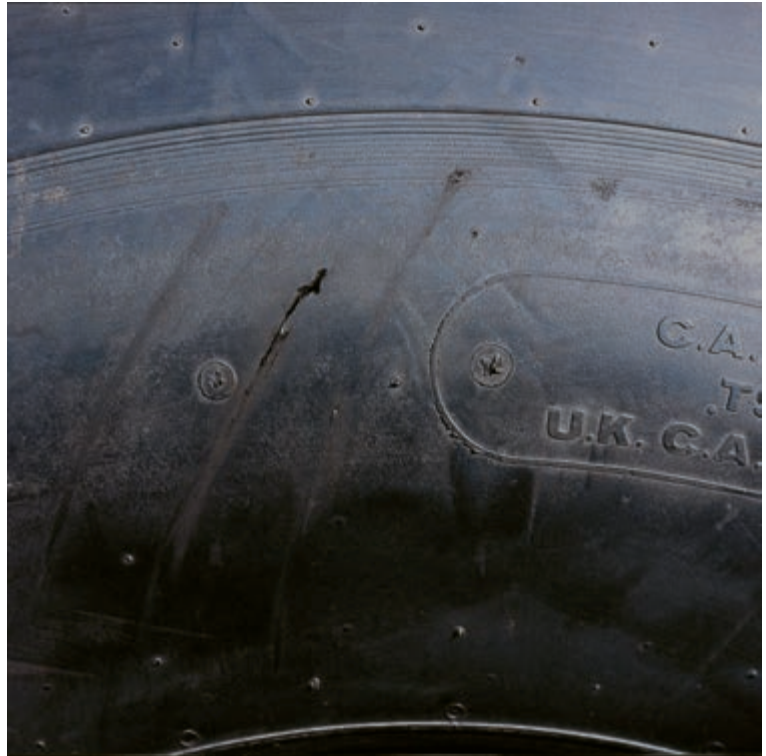
SIDEWALL CUTS

Sidewall cuts are often caused by foreign objects.

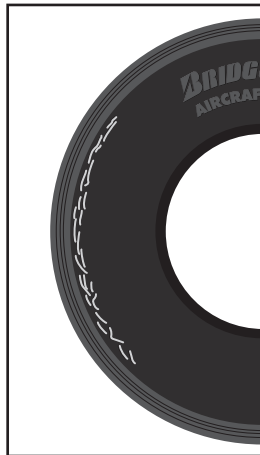
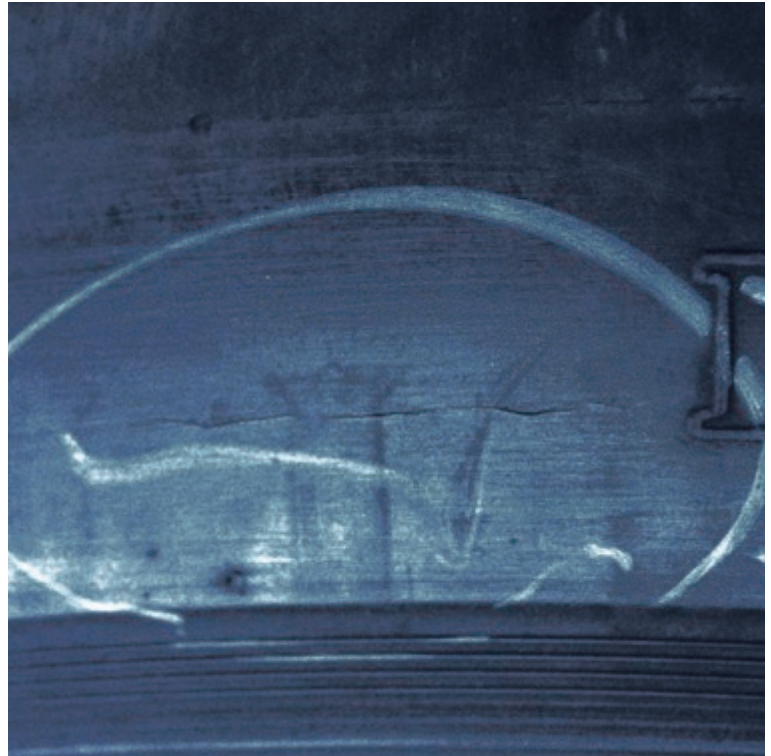
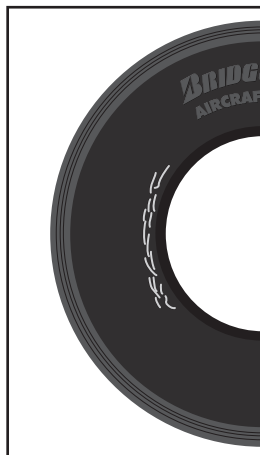
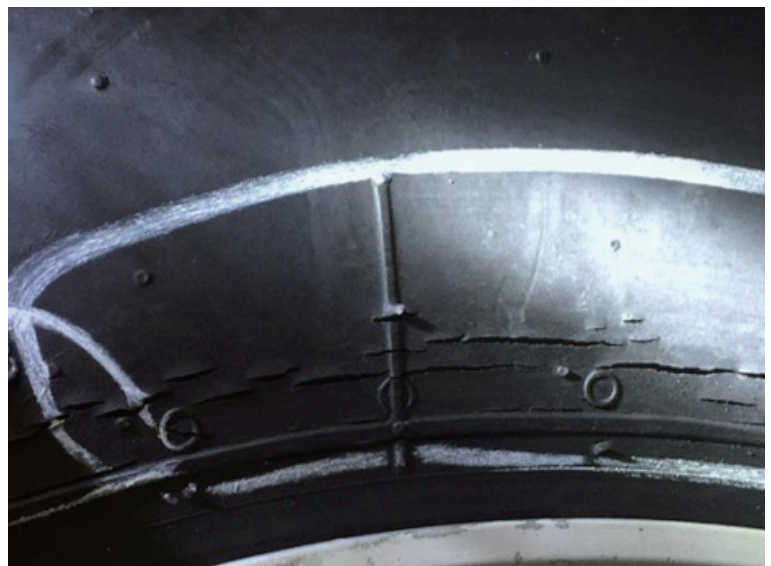
SIDEWALL CRACKING
 (Upper side and lower side)
 Circumferential cracks

Circumferential cracks are caused by load shear and stress combined with low tire inflation pressure. Cracking in the area where the tire touches the rim flange can occur due to the mechanical interaction between the rim flange and the lower sidewall of the tire during deflection.

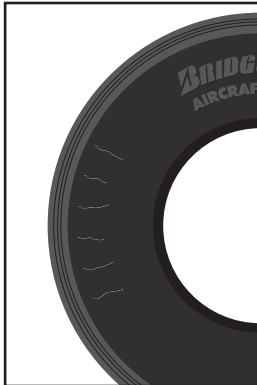
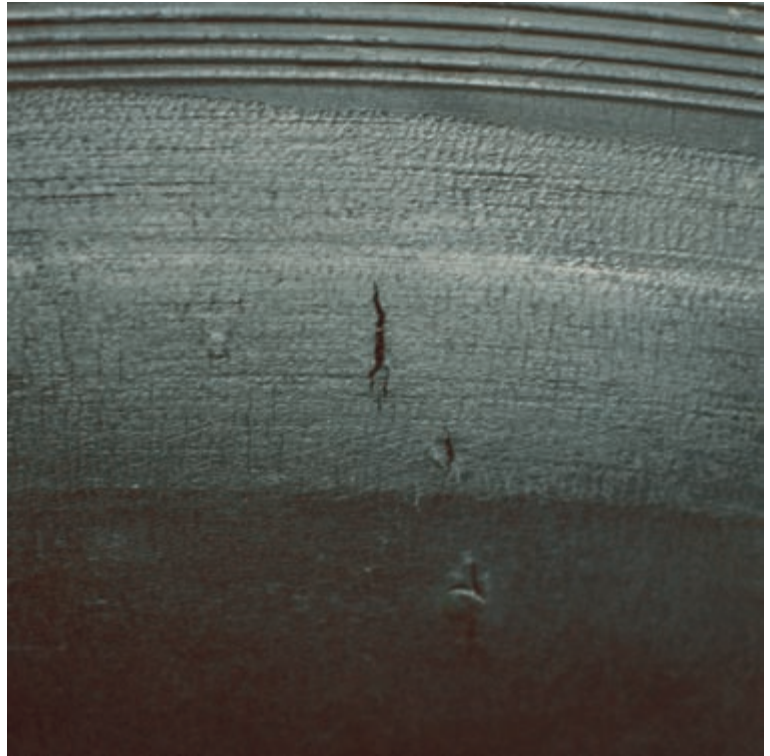
WEATHERING & RADIAL CRACKING

POSSIBLE CAUSES

Weathering and radial cracking occur when tires are exposed to ozone or to direct sunlight (ultraviolet rays) for extended periods of time, and are accelerated by insufficient tire inflation pressure.

RECOMMENDATION

If cords are exposed, remove the tire and scrap.

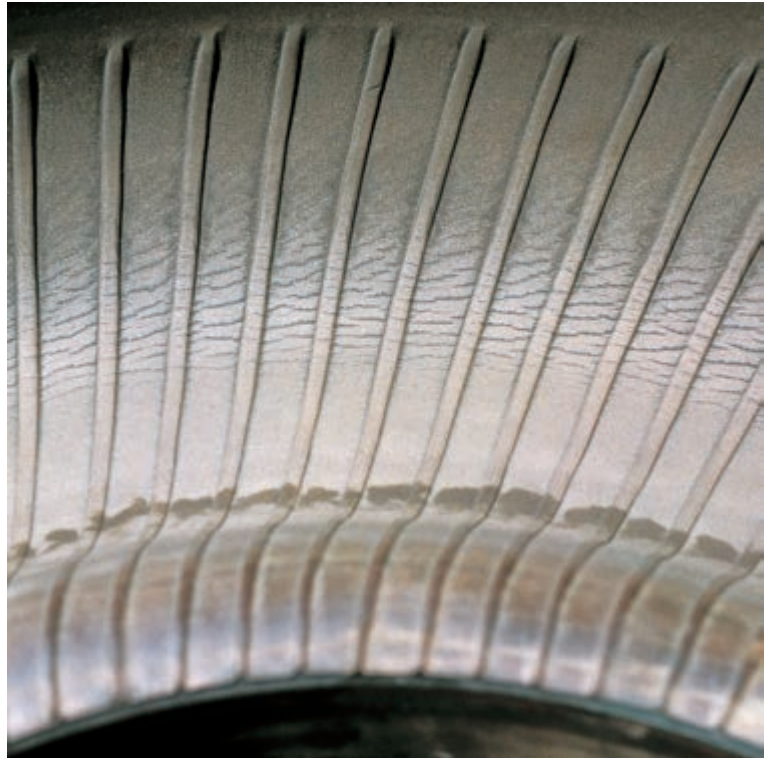
INNERLINER WRINKLING

POSSIBLE CAUSES

Wrinkling of the innerliner typically occurs due to over deflection of the tire. This type of damage can also indicate that the tire has experienced low inflation pressure conditions in service.

* Tires with innerliner wrinkling should be scrapped together with the axle mate tire, since both tires have been subjected to overloading.

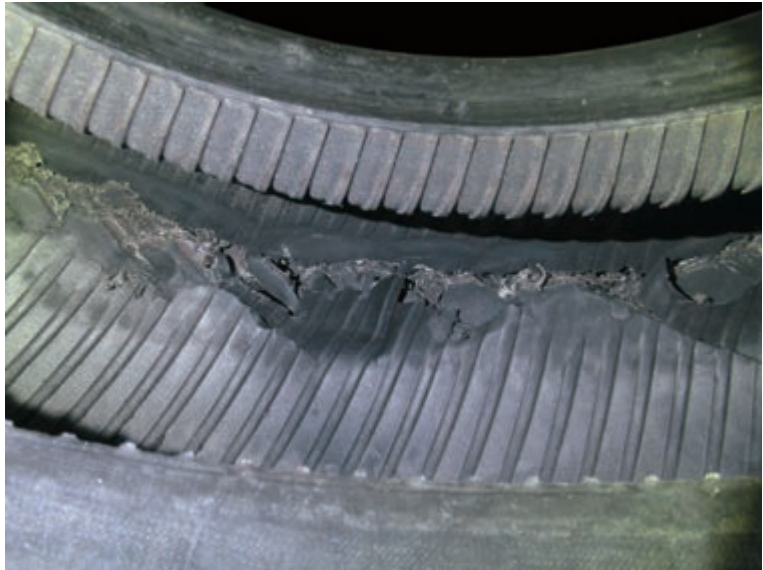
Upper sidewall

POSSIBLE CAUSES

This phenomenon is caused by under inflation operation with high deflection during taxi.

Whole appearance of the above tire

Outside appearance of this inner liner CBU tire.
Casing break up happens inside of tire shoulder area.
***Hard to detect from outside appearance.**

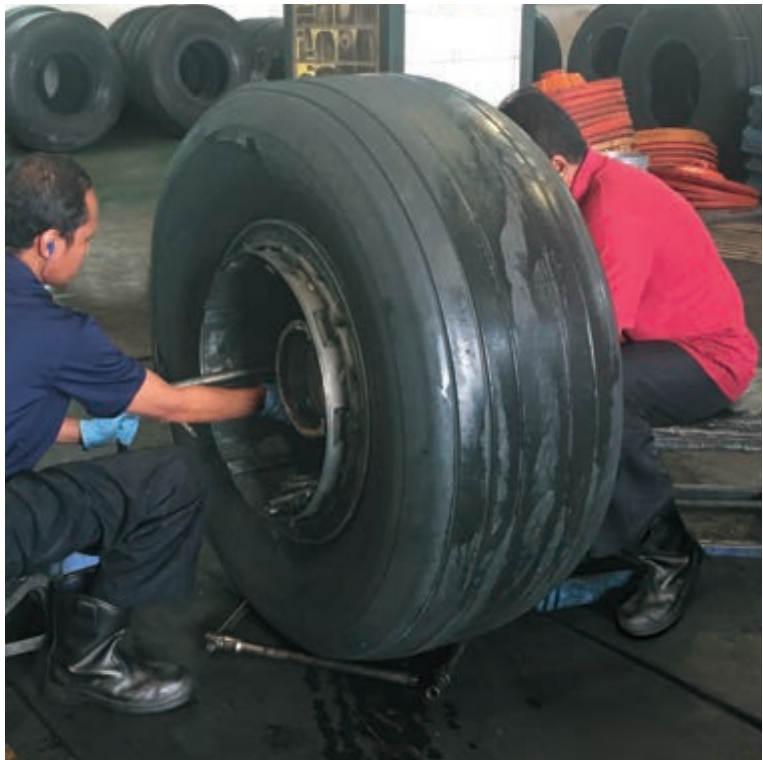
⚠ WARNING
IF THE INFLATION PRESSURE LOSS IS MORE THAN 10%, REPLACE THE TIRE.
IF YOU RE-INFLATE AND KEEP USING THE TIRE. THERE IS A RISK OF CASING BREAK UP.
* HARD TO DETECT FROM OUTSIDE APPEARANCE.

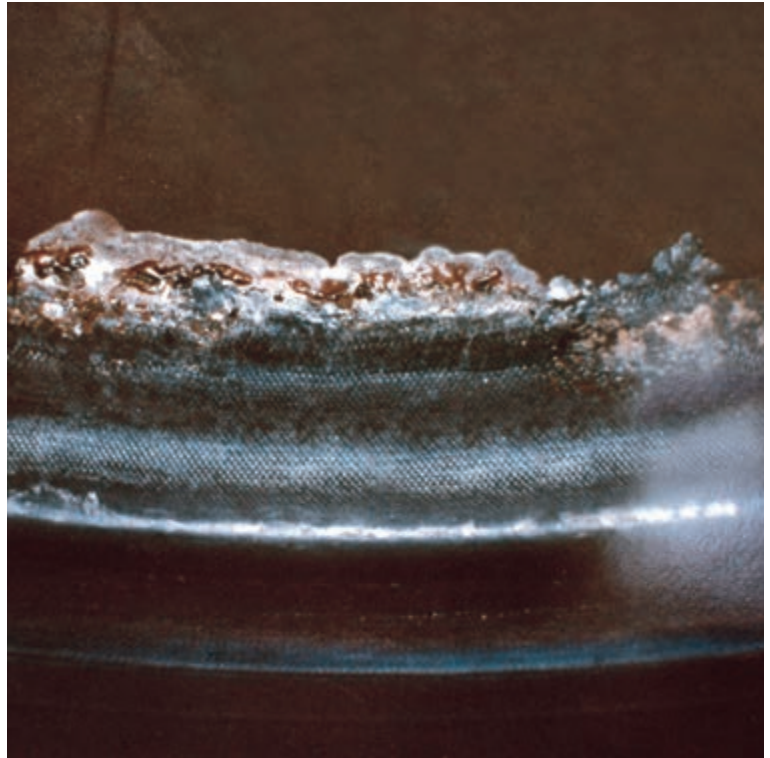
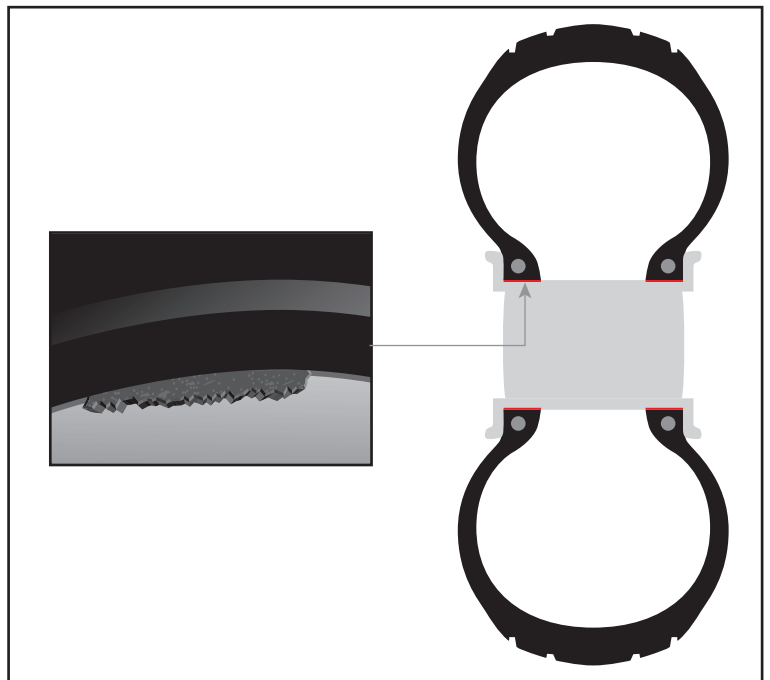
OVERHEATING FROM EXCESSIVE BRAKING

POSSIBLE CAUSES

Excessive braking or maladjusted brakes are liable to create high heat build-up, which may lead to melting of the rubber at the bead seat or toe/heel areas.

RECOMMENDATION

Remove the tire after it cools.

*Tires with signs of cord-melting due to overheating must be scrapped.

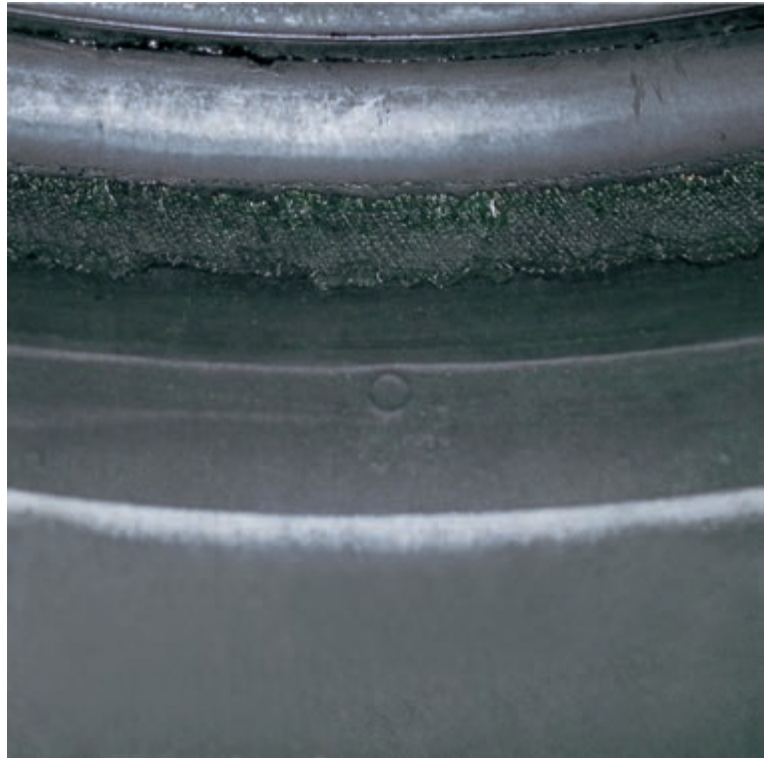
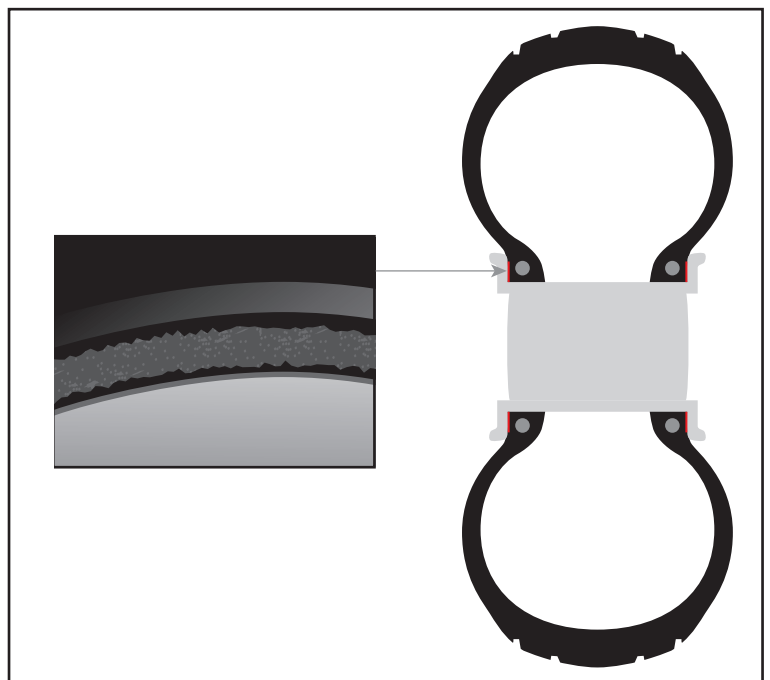
CHAFFER DAMAGE

POSSIBLE CAUSES

If the tire is mounted incorrectly on the rim or is mounted using a wrong tool, the tire beads may be damaged. Improper inflation of the tire and oil seepage between the tire bead and wheel rim flange may also cause chaffer damage. The damage shown on the right was caused by slippage between the tire and the rim.

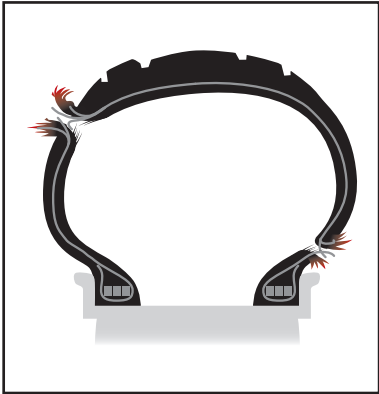
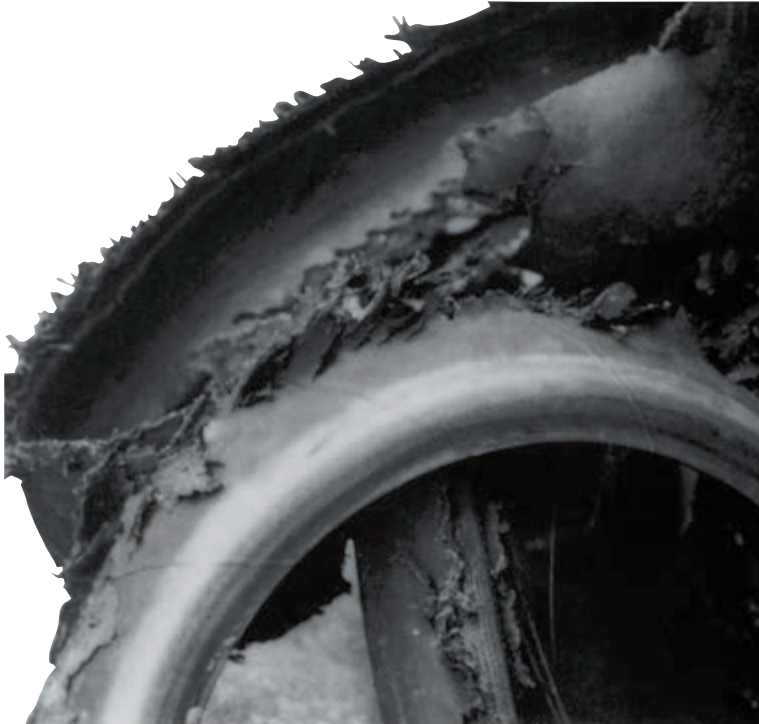
HEAT BURST

POSSIBLE CAUSES

Abnormal heat generation may occur at the bead and shoulder areas. In the worst case, bursting may result.
